Monitoring Morphology and Currents at the Hatteras Breach

ABSTRACT

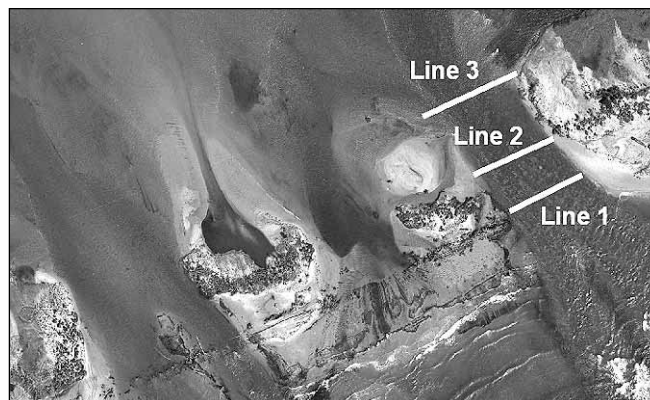
Figure 10. Approximate location of ADCP transects (NCDOT photograph).

Transect lines were chosen along three locations – approximately at the ocean end of the breach, near the middle, and on the sound side (Figure 10). The Zodiac crabbed (at an angle to the current) across the breach at a best attempt of constant speed, with each transect taking 2 to 3 min. Typically, two or three transects were made at each location before proceeding to the next line. Approximately 140 total transects were completed during both deployments. In addition, 12 current measurements were made using the boat as a drogue and currents computed from the recorded GPS time and position.
